Subject: May 13, 2014 CWA Compliance Evaluation Inspection

**CWA COMPLIANCE EVALUATION INSPECTION REPORT
U.S. ENVIRONMENTAL PROTECTION AGENCY, REGION 5**

Facility: Imperial Marble Corporation
327 East LaSalle Street
Somonauk, Illinois 60552
41.630716, -88.678245

Date of Inspection: 5/13/2014 – 5/14/2014

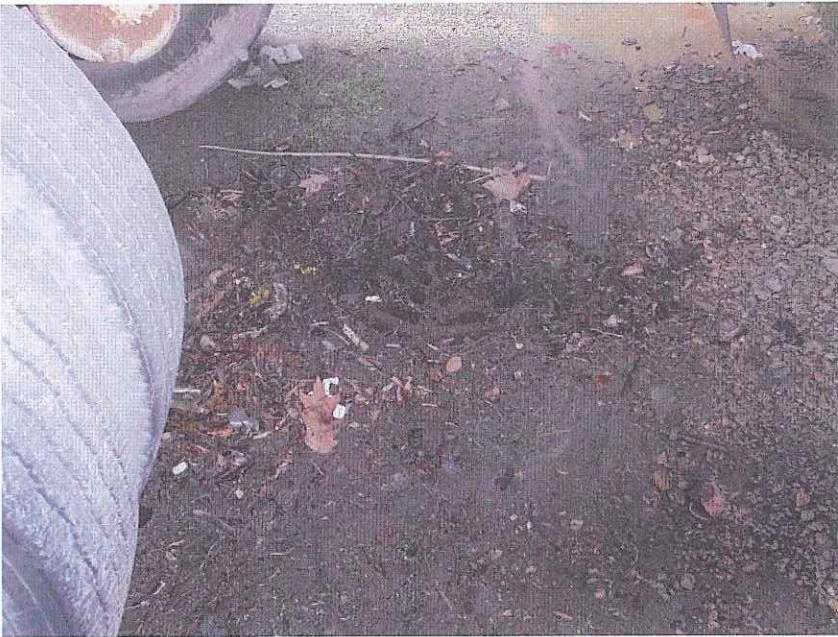
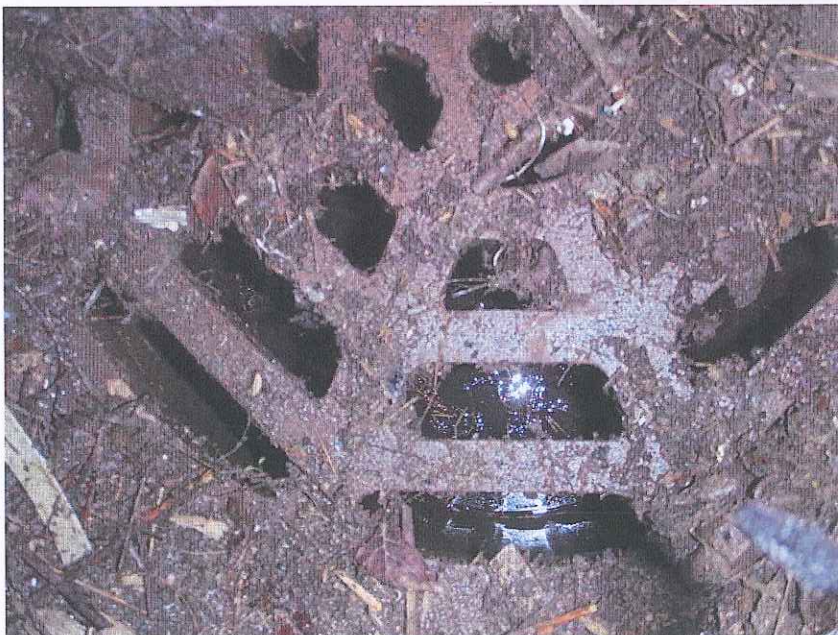
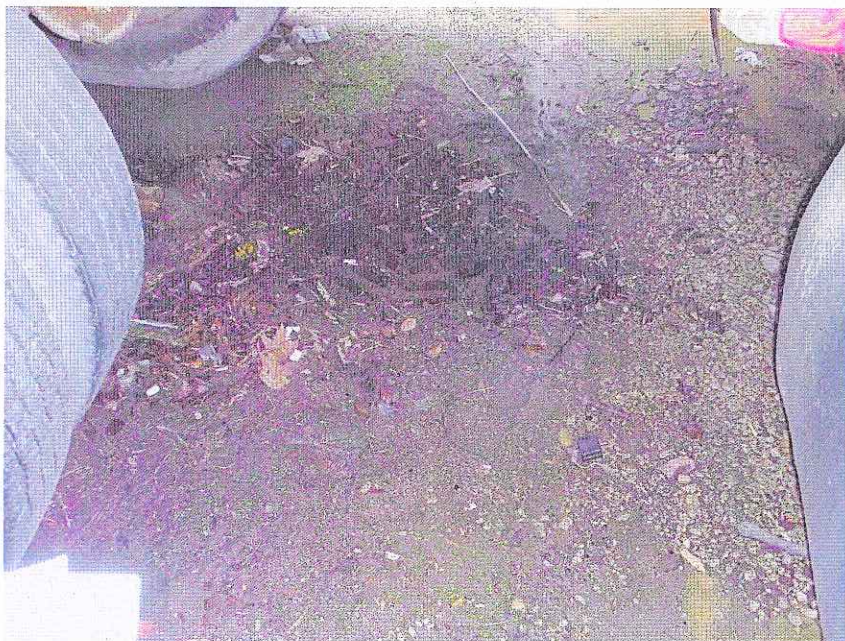
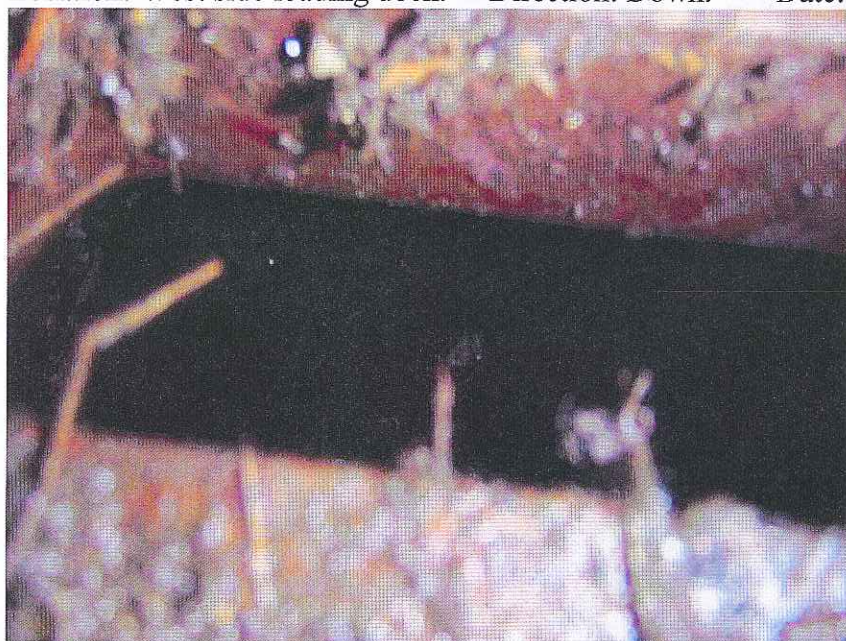
I observed a storm water drain located in the loading dock on the west side of the facility (photo P1010291, P1010286).

45: P1010284 Description: Storm water drain in west side loading dock.
Location: West side loading dock. Direction: Down. Date: 5/13/2014

46: P1010285 Description: Storm water drain in west side loading dock.
Location: West side loading dock. Direction: Down. Date: 5/13/2014

47: P1010286 Description: Storm water drain in west side loading dock.
Location: West side loading dock. Direction: Down. Date: 5/13/2014

48: P1010287 Description: Storm water drain in west side loading dock.
Location: West side loading dock. Direction: Down. Date: 5/13/2014

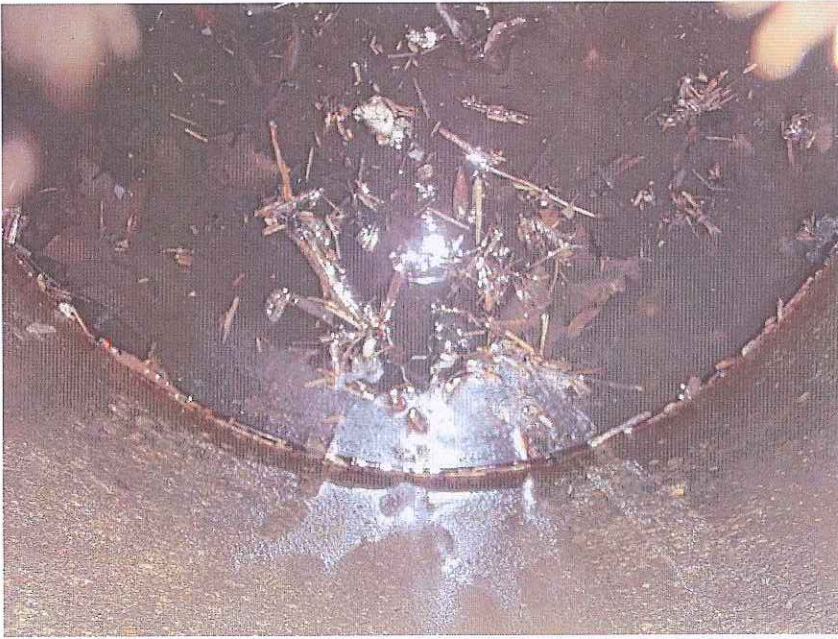
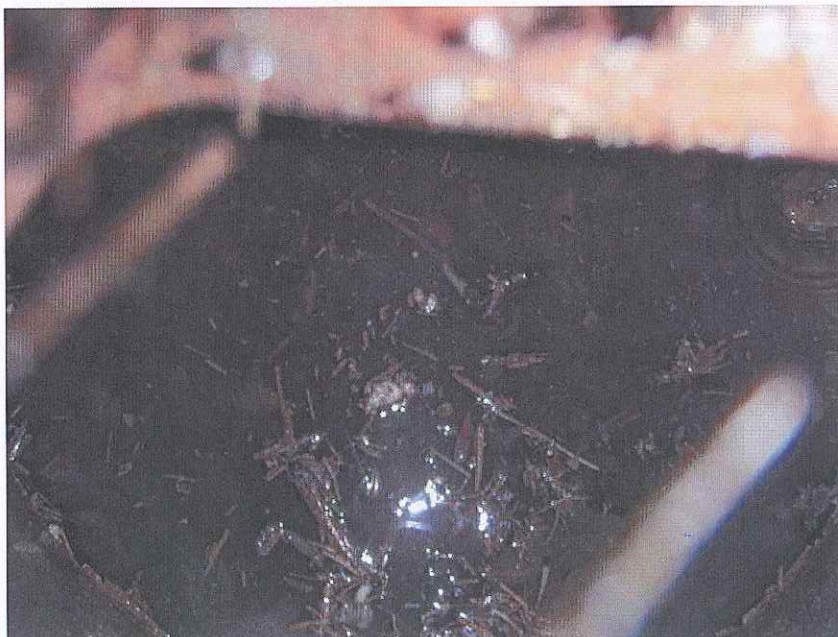
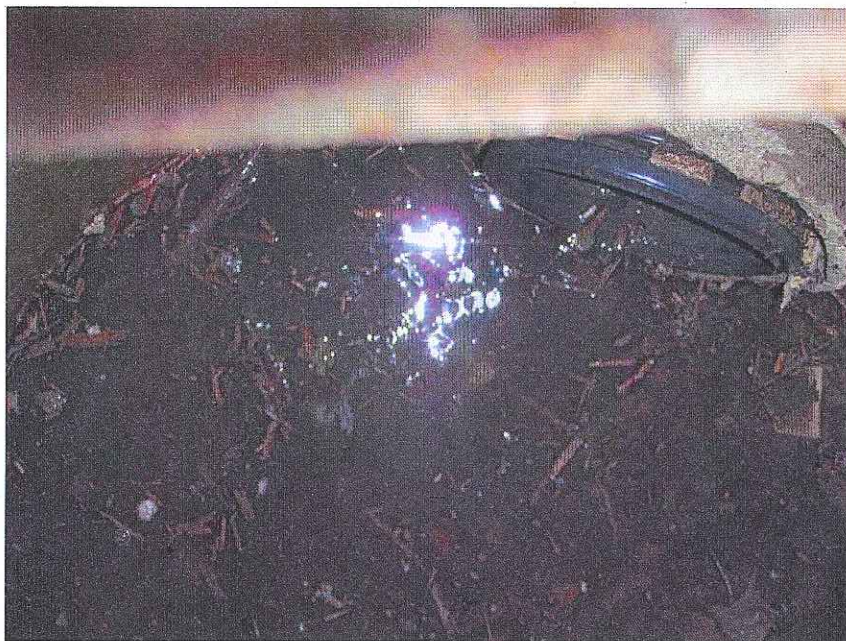
49: P1010288 Description: Interior of storm water drain in west side loading dock.
Location: West side loading dock. Direction: Down. Date: 5/13/2014

50: P1010289 Description: Interior of storm water drain in west side loading dock.
Location: West side loading dock. Direction: Down. Date: 5/13/2014

51: P1010290 Description: Interior of storm water drain in west side loading dock.
Location: West side loading dock. Direction: Down. Date: 5/13/2014

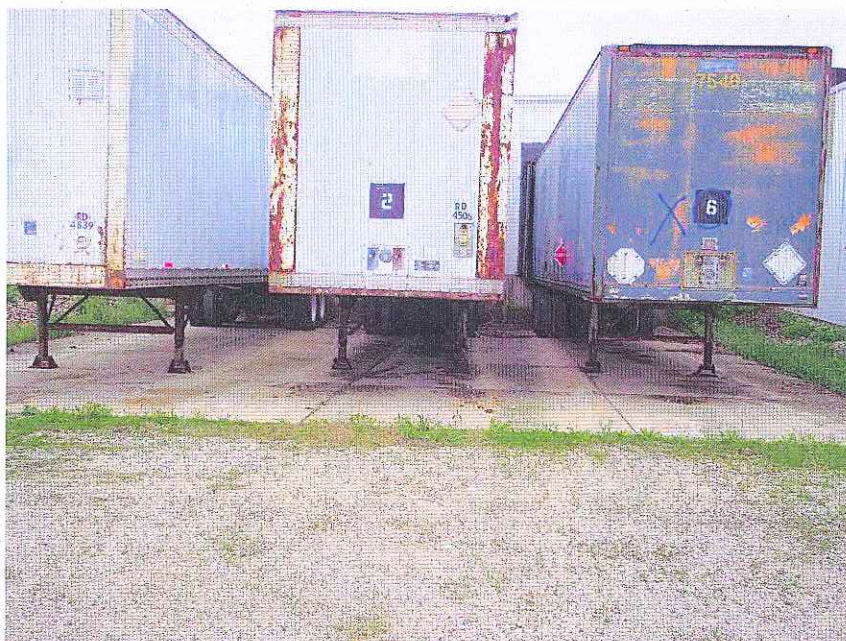
52: P1010291 Description: West side loading dock.
Location: West side loading dock. Direction: Down. Date: 5/13/2014

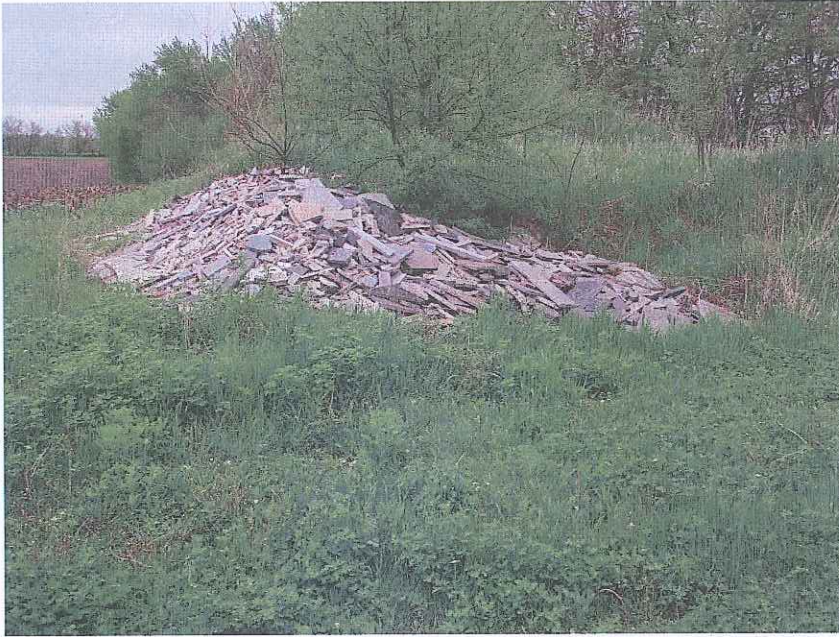
I observed a pile of waste stone from the time when IMC also cut natural stone bath surfaces (photo P1010292).

53: P1010292 Description: Pile of discarded natural stone from time when IMC manufactured cut stone bath surfaces. Location: Southwest of main plant. Direction: South. Date: 5/13/2014

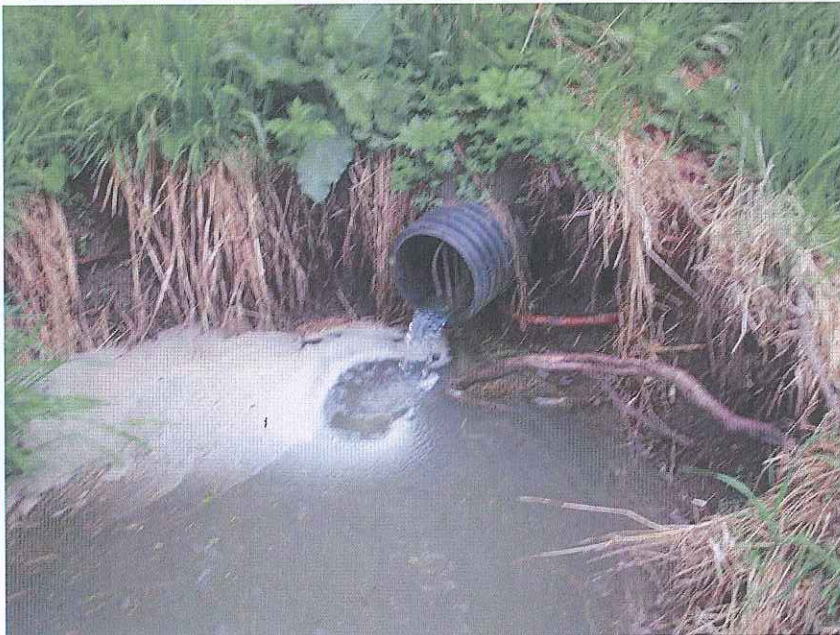
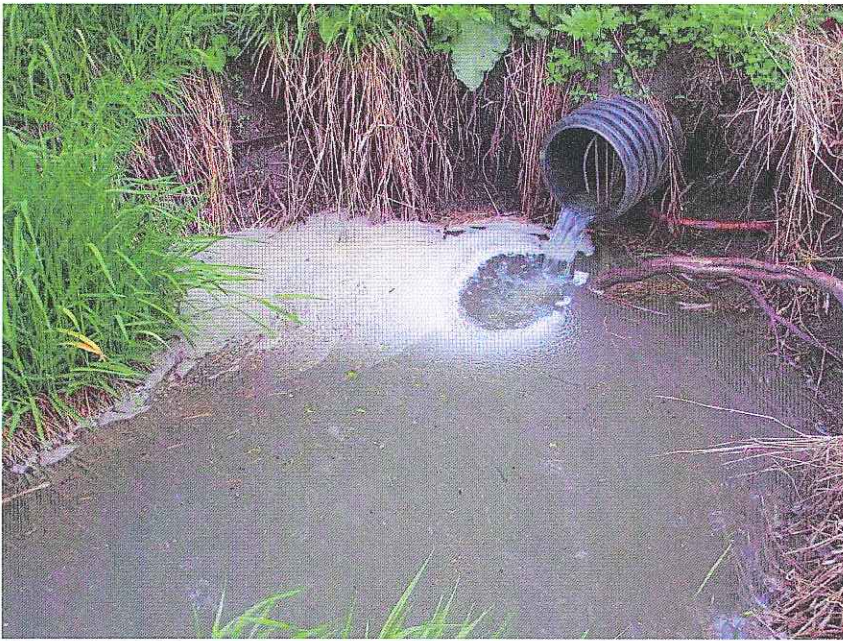
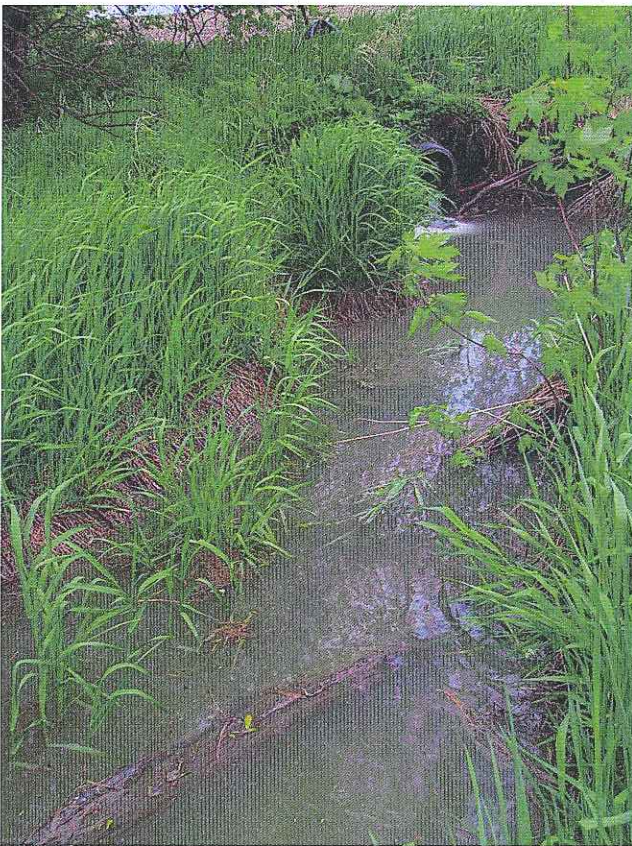
I walked to the outlet of the storm water drains located at the storm water retention pond south of the facility (Photo P1010294, P1010295, and P1010296). I observed an off-white foam on the surface of the water immediately at the outlet (Photo P1010297).

54: P1010293 Description: Outfall of storm water collection system. Location: East side of storm water retention pond. Direction: North. Date: 5/13/2014

55: P1010294 Description: Outfall of storm water collection system.
Location: East side of storm water retention pond. Direction: North. Date: 5/13/2014

56: P1010295 Description: Outfall of storm water collection system.
Location: East side of storm water retention pond. Direction: Northeast. Date: 5/13/2014

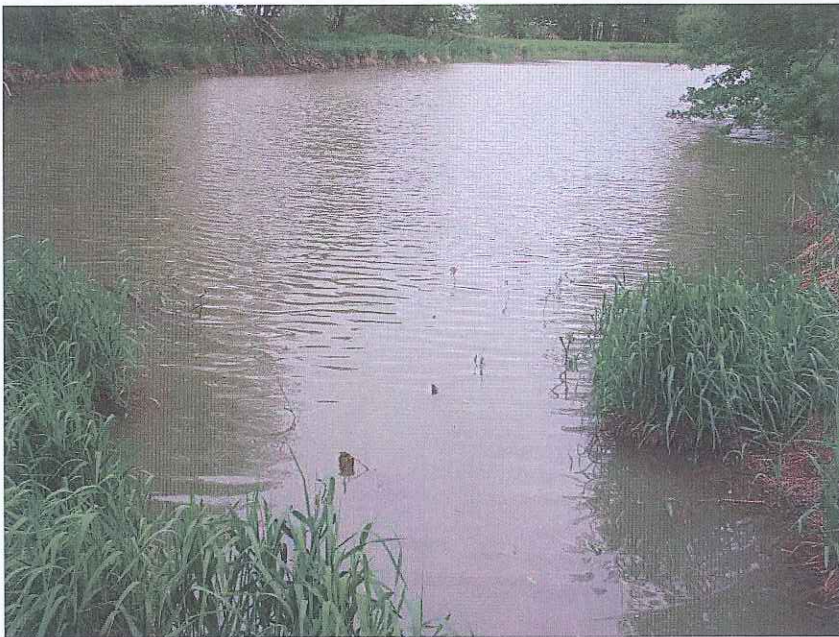
I walked around the storm water retention pond and found that the pond appeared to be located at the low point of a bowl feature with no outlet to surface waters.

57: P1010296 Description: Storm water retention pond.

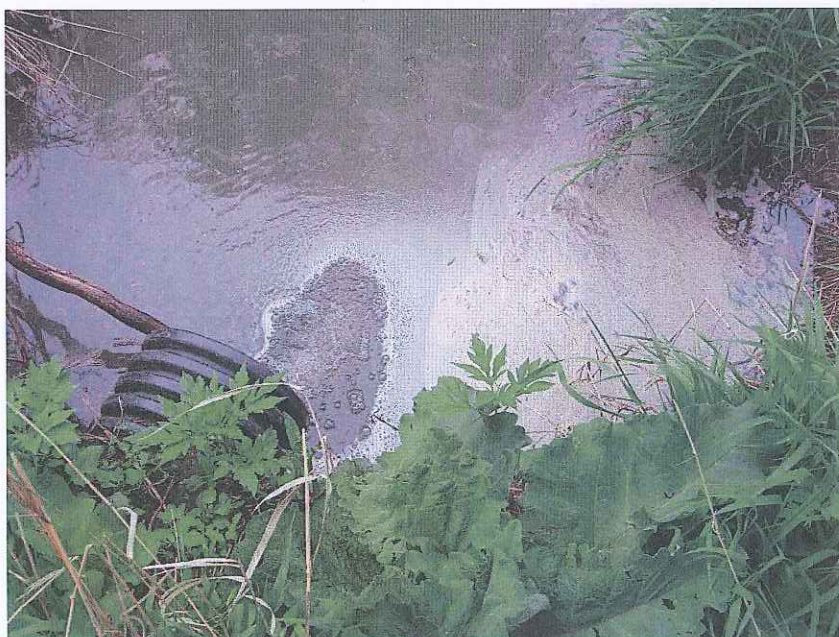
58: P1010297 Description: Outfall of storm water collection system.

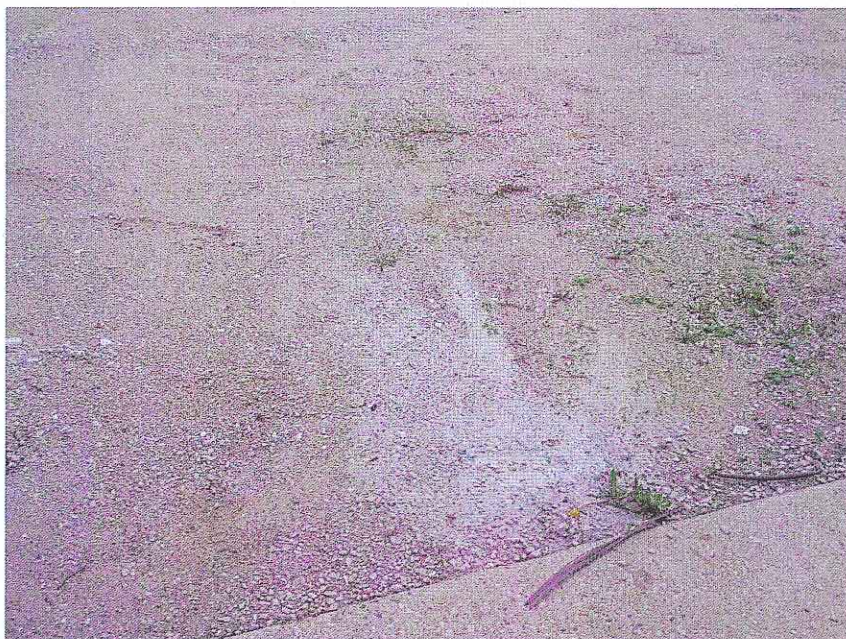
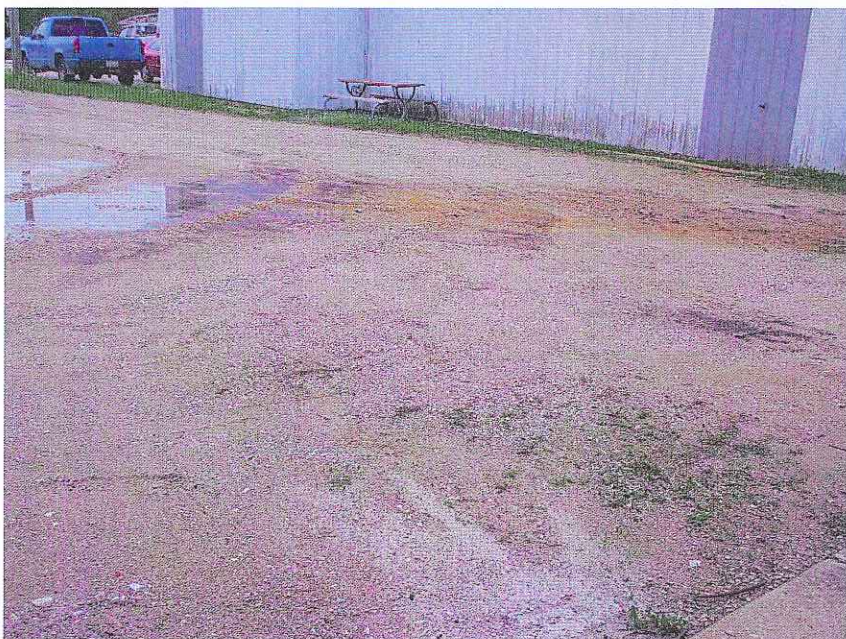
I observed the parking area on the east side of the facility (Photo P1010245) as well as the resin unloading area (Photo 1010241). The very north end of the driveway and parking area appeared to drain to the north to the roadside ditch while the remainder of the Facility's storm water flowed to the Facility's storm water collection drains.

59: P1010298 Description: Resin unloading area on north end of main plant.
Location: North end of main plant. Direction: Southeast Date: 5/14/2014

60: P1010299 Description: Resin unloading area on north end of main plant.
Location: North end of main plant. Direction: Southeast Date: 5/14/2014

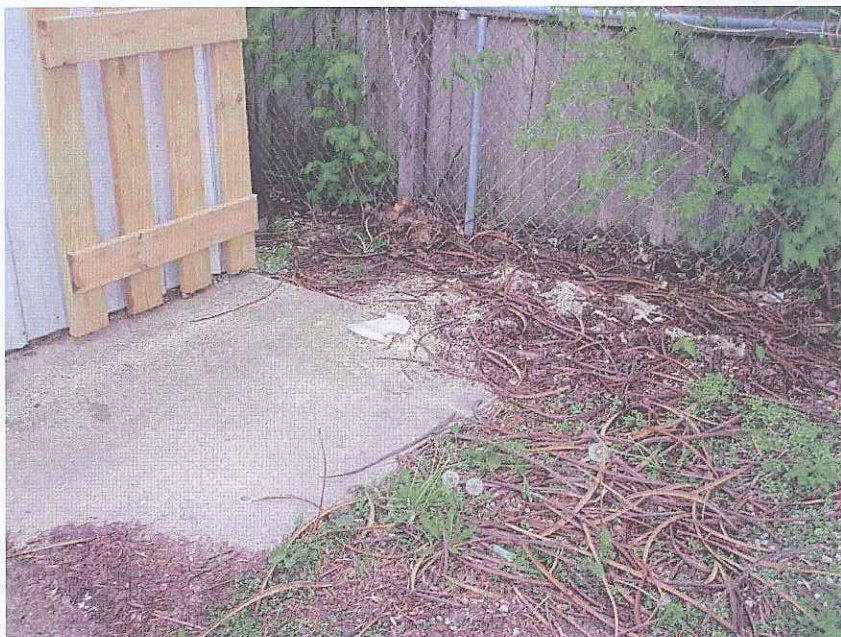
61: P1010300 Description: Gate on north side of main plant to access areas on west side of main plant.
Location: Northwest corner of main plant. Direction: West. Date: 5/14/2014

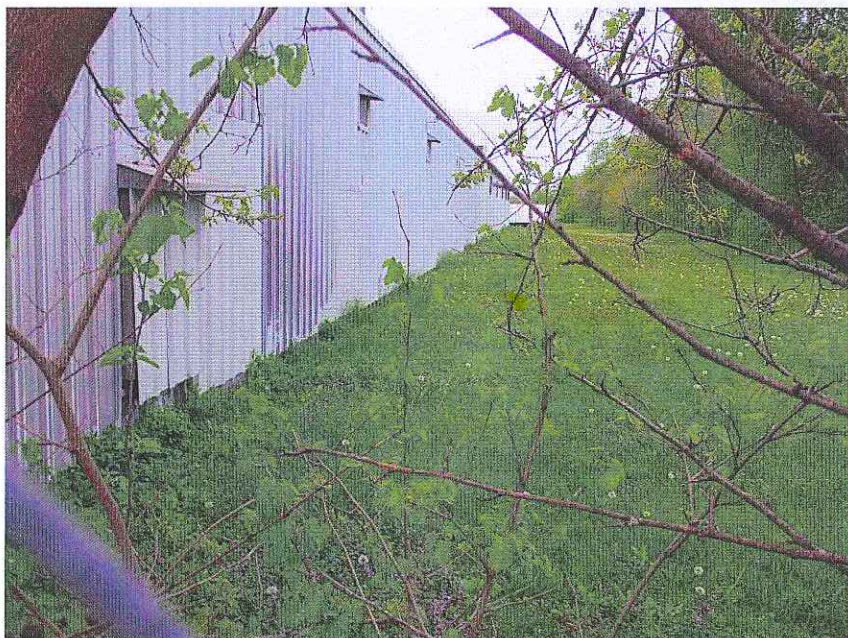
On the second day of the inspection, 5/14/2014, I walked on the west side of the main plant from north to south. I observed the grassed storm water swale located west of the main plant (photo P1010303).

64: P1010303 Description: Grass swale on west side of main plant.

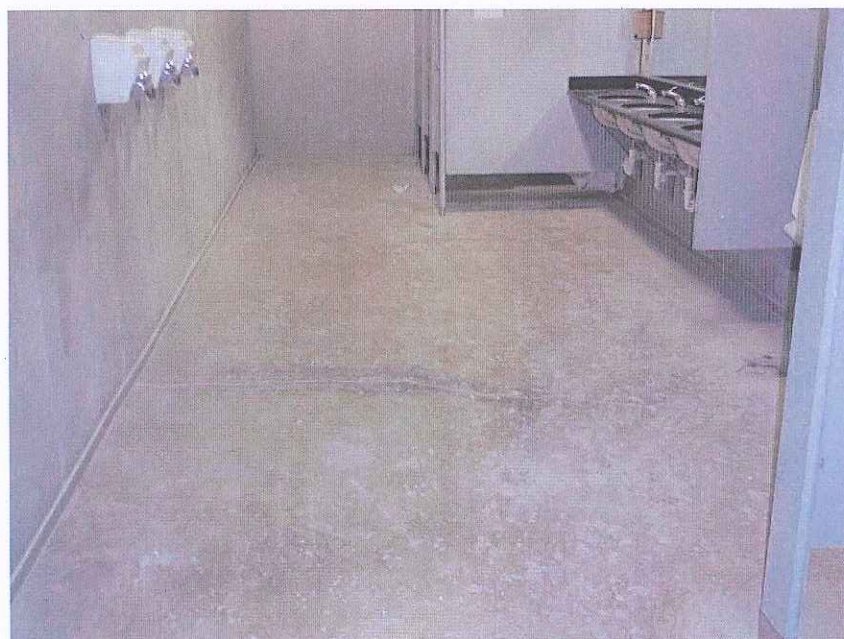
70: P1010309 Description: Only floor drain observed inside of IMC.
Location: Employee restroom. Direction: NA Date: 5/14/2014
